Managing safety and controlling the risk of rockfalls at development faces

Lima, 14 July 2019

Case Study

- 10 February 2015 Incident
- Olympic Dam Mine
- Jumbo Drill Operator
- Drilling out a development face, approx. 75% complete
- Changing drill bit
- Tragically killed when crushed by rocks that fell from the face
- Facts:
 - Face not supported
 - Changing a drill bit
 - Ground conditions noise

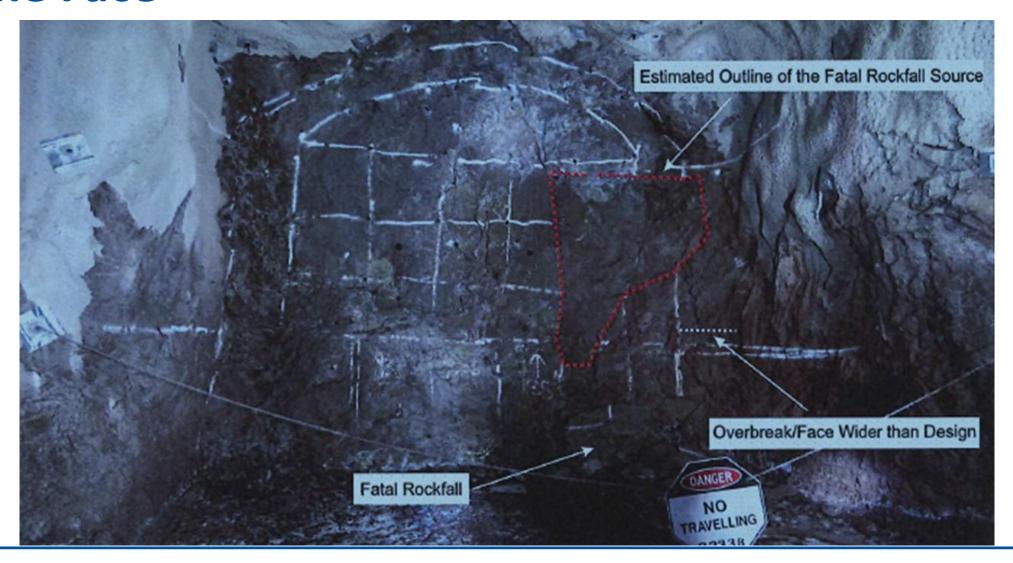
The Face

- Slot drive over break
- Face slightly undercut
- Approx 1200 kg slab toppled / popped off face
- The drilling (i.e. vibration / percussion) and the associated water disturbed the rock face
- The water from the drilling would have seeped in behind the slab causing minor hydraulic pressure behind the slab
- Likely that a mini strain burst occurred just before the rock dislodged

- South Australia
 - 2m exclusion zones at faces, after lifters installed
 - Engineering control mesh and bolt faces, fibrecrete
 - Improved systems of work for persons in the vicinity of faces
 - All UG mines now install ground support on all faces
 - Greatly reduced the risk of rock falls from faces
 - No major impact on cost or cycle times
- Australia
 - Supporting faces in cycle now common practice
