Managing safety and controlling the risk of rockfalls at development faces

Lima, 14 July 2019

Case Study

- 10 February 2015 Incident
- Olympic Dam Mine
- Jumbo Drill Operator
- Drilling out a development face, approx. 75% complete
- Changing drill bit
- Tragically killed when crushed by rocks that fell from the face
- Facts:
 - Face not supported
 - Changing a drill bit
 - Ground conditions noise

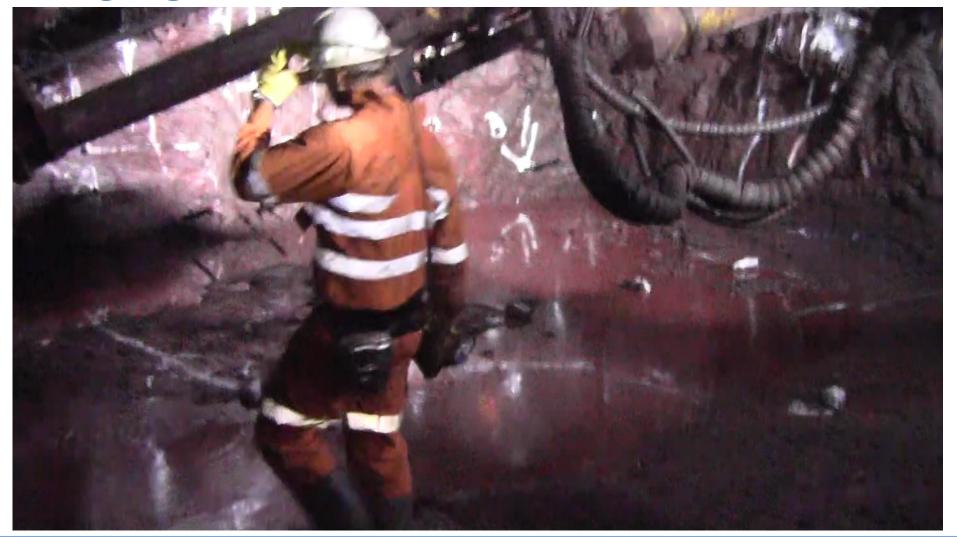
Changing a bit

- Changing of drills bits and drill rig maintenance not covered
- Access to faces only restricted prior to charging hand scaling
- No exclusion zones at faces once drilling has commenced
